Manhole Inspection Summary

Manhole # S37WW_010MH

Insp Date: 1/10/07 11:24 AM

Location Address: **704 MONTPELIER ST**

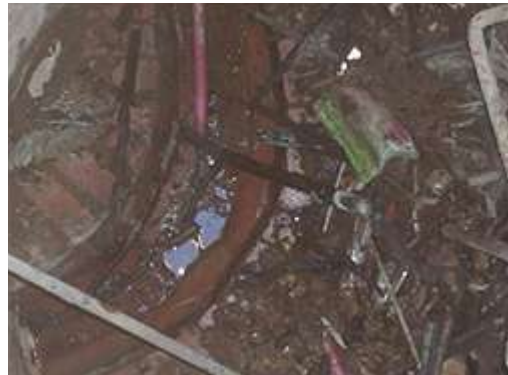
Top View

Bench ☒ Exists Material: **Brick** ☐ Parged ☒ **Debris** (not Condition related)

Surcharge ☒ **Evidence Of Surcharge** Depth: **1.5** (ft.) ☐ Active Surcharge Present

Evidence of surcharge - Bench debris.

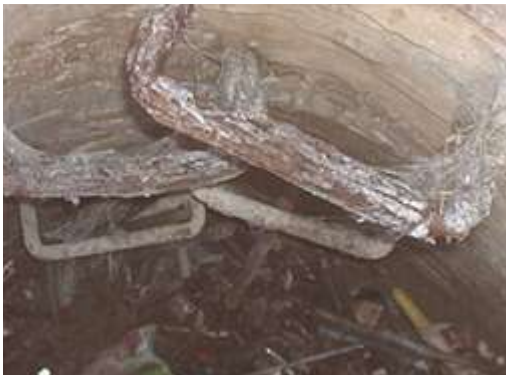
Defect

Steps Count: **4** Missing: **0** ☒ **Corroded**

Corroded steps.

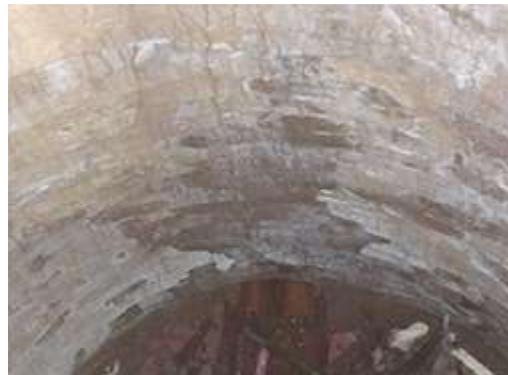
Defect

Infiltration: ☐ None ☐ Joint ☐ Cracks ☐ Mortar ☐ Roots ☒ **Wall**

Barrel infiltration.

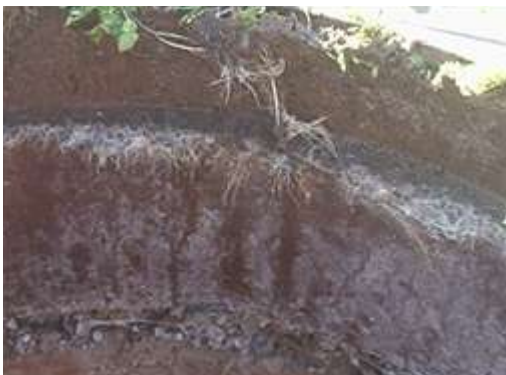
Defect

Condition: ☐ Sound ☐ Cracked ☐ Root Intrusion ☐ Loose Brick ☒ **Deteriorated**

Infiltration: ☐ None ☒ **Joint** ☐ Cracks ☐ Mortar ☐ Roots ☒ **Wall**

Adjustment deterioration and infiltration.

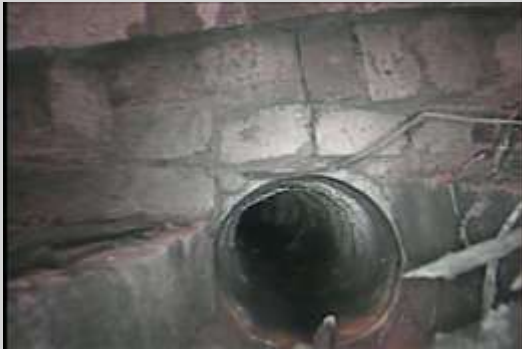
8 in. Circular Gravity Sewer Pipe Out @ 12 O'Clock

Deposits: ☐ None ☐ Mud ☐ Sludge ☐ Debris ☒ Grease

Silt Depth: **0** (in.) Deposits Extent: **Light**

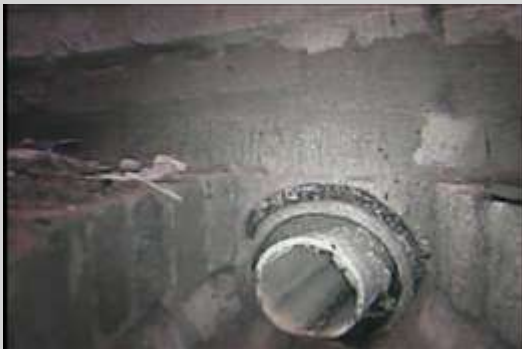
4 in. Circular Gravity Sewer Pipe In @ 9 O'Clock

Infiltration: **Evidence** Pipe Seal Cond: **Unknown**
